#### What happened?

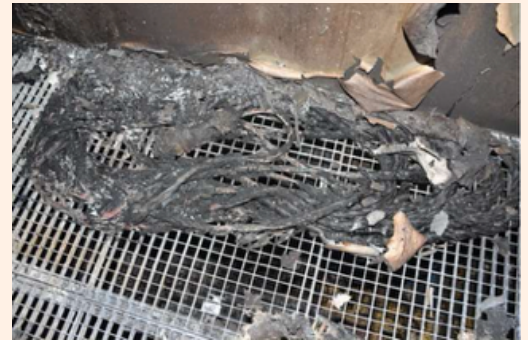
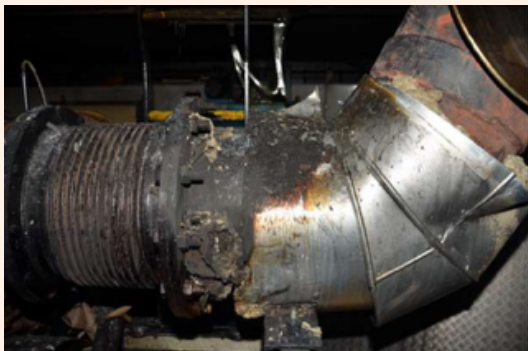
The electricity cables and the controls for the car crane that were on grates above the main engine were fused to the top of unshielded engine parts due to the radiating temperature. The melted rubber has led to a small fire starting at the top of the exhaust manifold, the exhaust gas pipe and the turbos.

Major material damage occurred in the engine room. There were several melted electrical cables. The main engine had to be overhauled.

After repairing an exhaust gas pipe connection piece, the insulation material was not placed back correctly. This caused great heat above the engine, causing the electrical cables to melt, resulting in a fire.

After every repair or maintenance, it must be checked whether the insulation has been returned to good condition.
