With this Safety Alert, we wish to draw your attention to a changed situation on the Rhein-Herne Canal between kilometre 18,8 and 20,8.

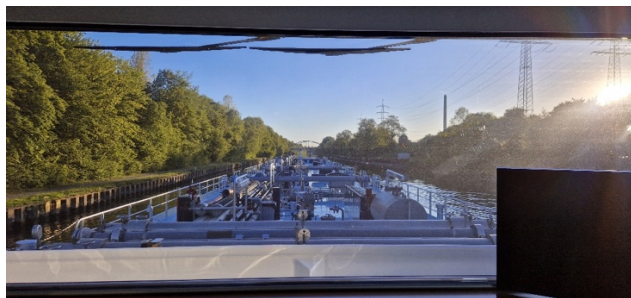
There has been damage to the sheet piling at this location for a long time, requiring vessels to pass with caution. However, the red buoys have been relocated since April 29, 2026, causing them to narrow the navigation channel even further.

The navigation channel is currently 16 meters wide. The permitted barge size is 11,45 meters.

As a result, the buoyage is not visible when navigating by radar, as it is lost in the echo of one's own barge.

- Reduce your speed in good time
- Use cameras or mirrors on the side of the ship to keep the buoyage visible
- Take oncoming barges into account, even if they are (temporarily) not visible on the AIS
