With this Safety Alert, we wish to draw your attention to a changed situation on the Rhein-Herne Canal between kilometre 18,8 and 20,8.

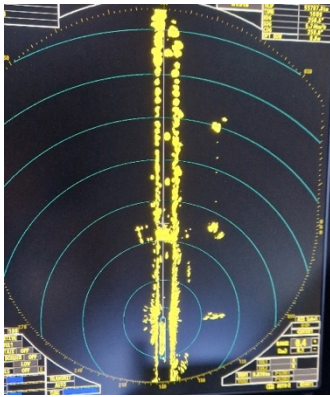
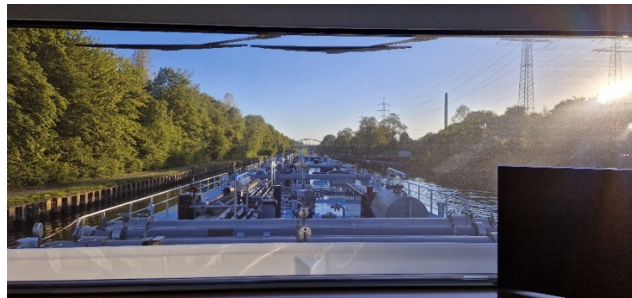
There has been damage to the sheet piling at this location for a long time, requiring vessels to pass with caution. However, the red buoys have been relocated since April 29, 2026, causing them to narrow the navigation channel even further.

The navigation channel is currently 16 meters wide. The permitted barge size is 11,45 meters.

As a result, the buoyage is not visible when navigating by radar, as it is lost in the echo of one's own barge.

- Reduce your speed in good time
- Use cameras or mirrors on the side of the ship to keep the buoyage visible
- Take oncoming barges into account, even if they are (temporarily) not visible on the AIS
