An engine room fire occurs more than once a month in the barge industry, and can cause for severe consequences for the safety of barge and crew.

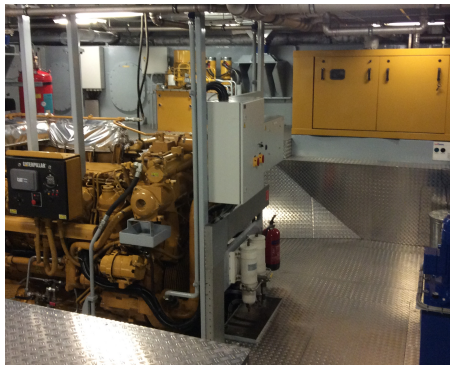
Engine room is maintained and well kept.
